STEEL CLAD PLATES HYDROGEN DEGRADATION EVALUATION USING ULTRASONIC DEFECTOSCOPY METHOD

S u m m a r y

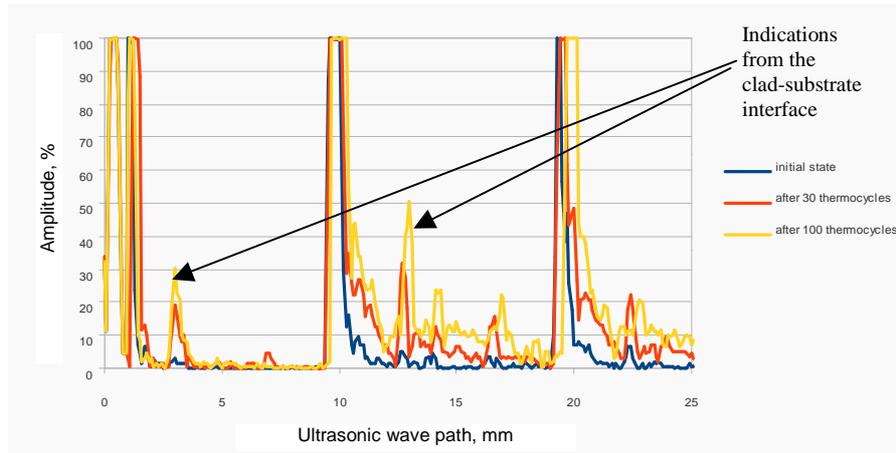
Some areas were identified in the samples where increased amplitude of the signal received from the clad-substrate interface was detected (Fig. 1). The amplitude rises along with the number of thermocycles. This indicates a progressive material degradation in the interface zone. Such degradation is related to both the difference of hydrogen diffusion and solubility in the joined materials and to hydrogen trapping [4, 5]. The hydrogen induced micro-cracks may eventually lead to delamination of the cladding.

It should be noted that the material, despite the occurring discontinuities, meets the requirements of the ASTM A 578 standard, because none of the peaks obtained from the clad-substrate interface exceeds 50% of the value of the peak from the sample bottom.

Fig. 1. Ultrasonic wave spectrum before and after thermocycling

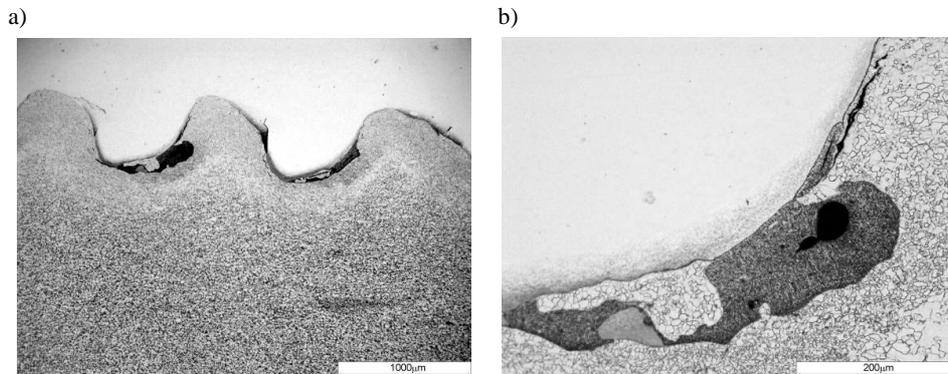
Microscopy examination was carried out in the areas showing increased amplitude of ultrasonic signal. The microscopic observations revealed a developed (wavy) character of the joint (Fig. 2a, 3a), and presence of transition zones as heavier etched areas (Fig. 2b, 3b). These structures are typical for joints made by an explosive method. The near interface zone was found to show porosity and non-metallic inclusions. Also linear discontinuities were revealed by the scanning electron microscopy (Fig. 4).

Fig. 2. Microstructure of clad-substrate interface after 30 thermocycles: a) magn. 100x, b) magn. 500x

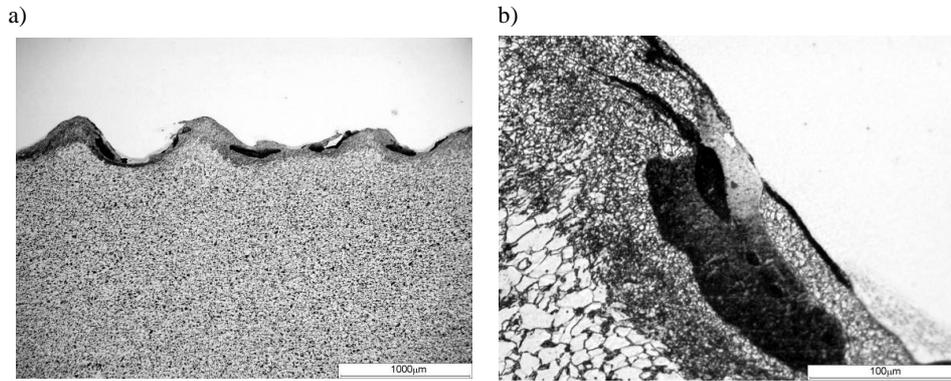
Fig. 3. Microstructure of clad-substrate interface after 100 thermocycles: a) magn. 100x, b) magn. 1000x

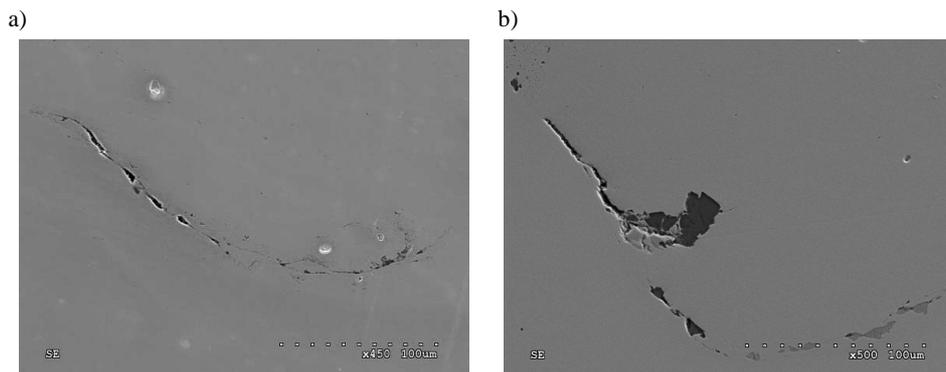
The SEM examination revealed that the discontinuities observed in the base-cladding joint are of a micro-crack type (Fig. 4a, b). Non-metallic

Fig. 4. SEM images made in the spots of increased ultrasonic signal amplitude: a) sample after 30 thermocycles, b) sample after 100 thermocycles

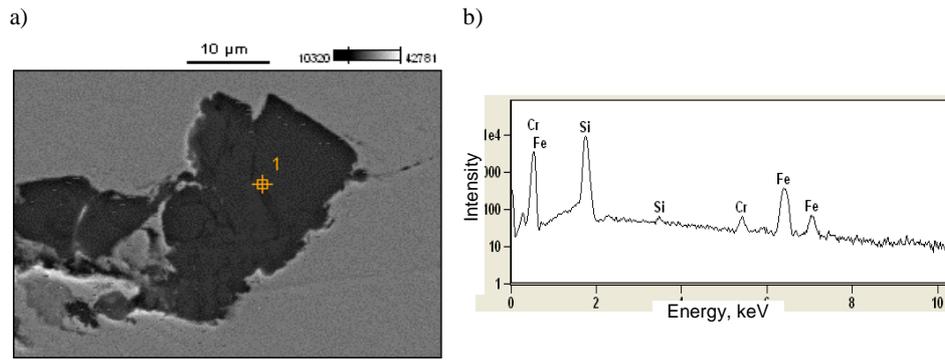
inclusions were found close to those micro-cracks. Their chemical composition, determined using the EDS method, revealed that they are rich in silicon (Fig. 5), which indicates the presence of sand particles at the joint zone. These sand particles are most likely trapped between the metal sheets during the explosive joining process. The results obtained here show that such type inclusions may be the cause of micro-crack initiation by hydrogen.

Fig. 5. Non-metallic inclusion promoting microcrack nucleation (a) and its EDS analysis (b)

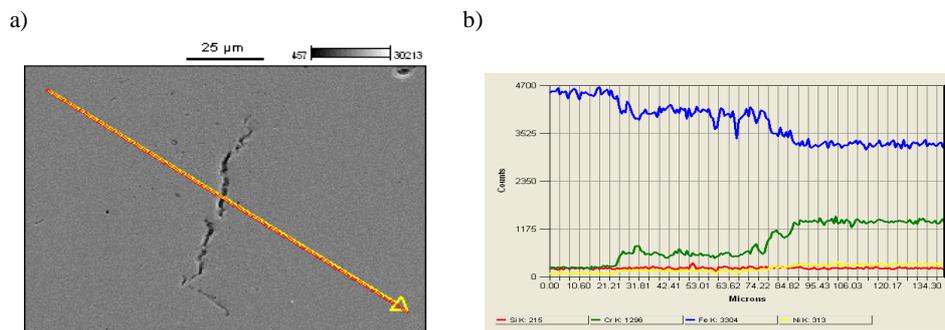
The line-based analyses of chemical composition (Fig. 6), carried out in a direction perpendicular to the micro-cracks, show that it runs along the base-cladding joint. Also, the presence of a transition zone between the base and the cladding materials can be observed. The diagram shows an increasing content of Cr and decreasing of Fe.

Fig. 6. STEM image (a) and EDS line scan conducted in the perpendicular direction through the microcrack (b)

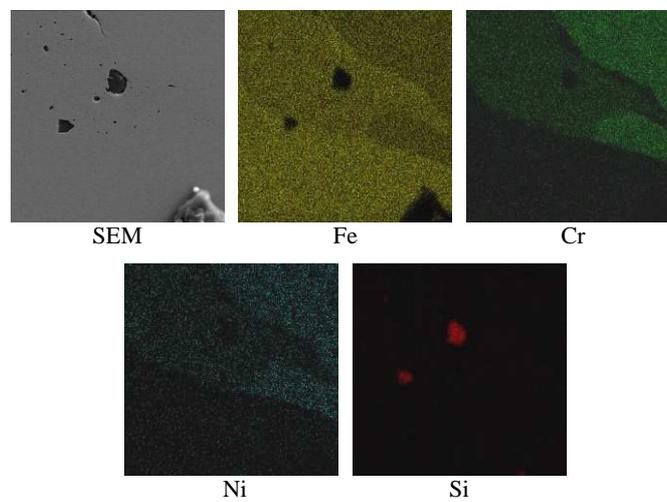
Fig. 7. The surface distribution of the alloying elements in transition zone in the joint area

The presence of a transition zone in the joint area is more visible in the element mapping made by the EDS method (Fig. 7). The changes of colour saturation indicate changes of content of an element. Silicon (Si) rich inclusions are clearly visible within the transition zone, which confirms that their origin (sand particles).
